**MERCURY INVESTIGATION
SOIL AND SEDIMENT SAMPLING
RESULTS**

**FAA William J. Hughes Technical Center
Atlantic City International Airport, New Jersey**

April 1998

Prepared by
**TRC Environmental Corporation
Windsor, Connecticut**

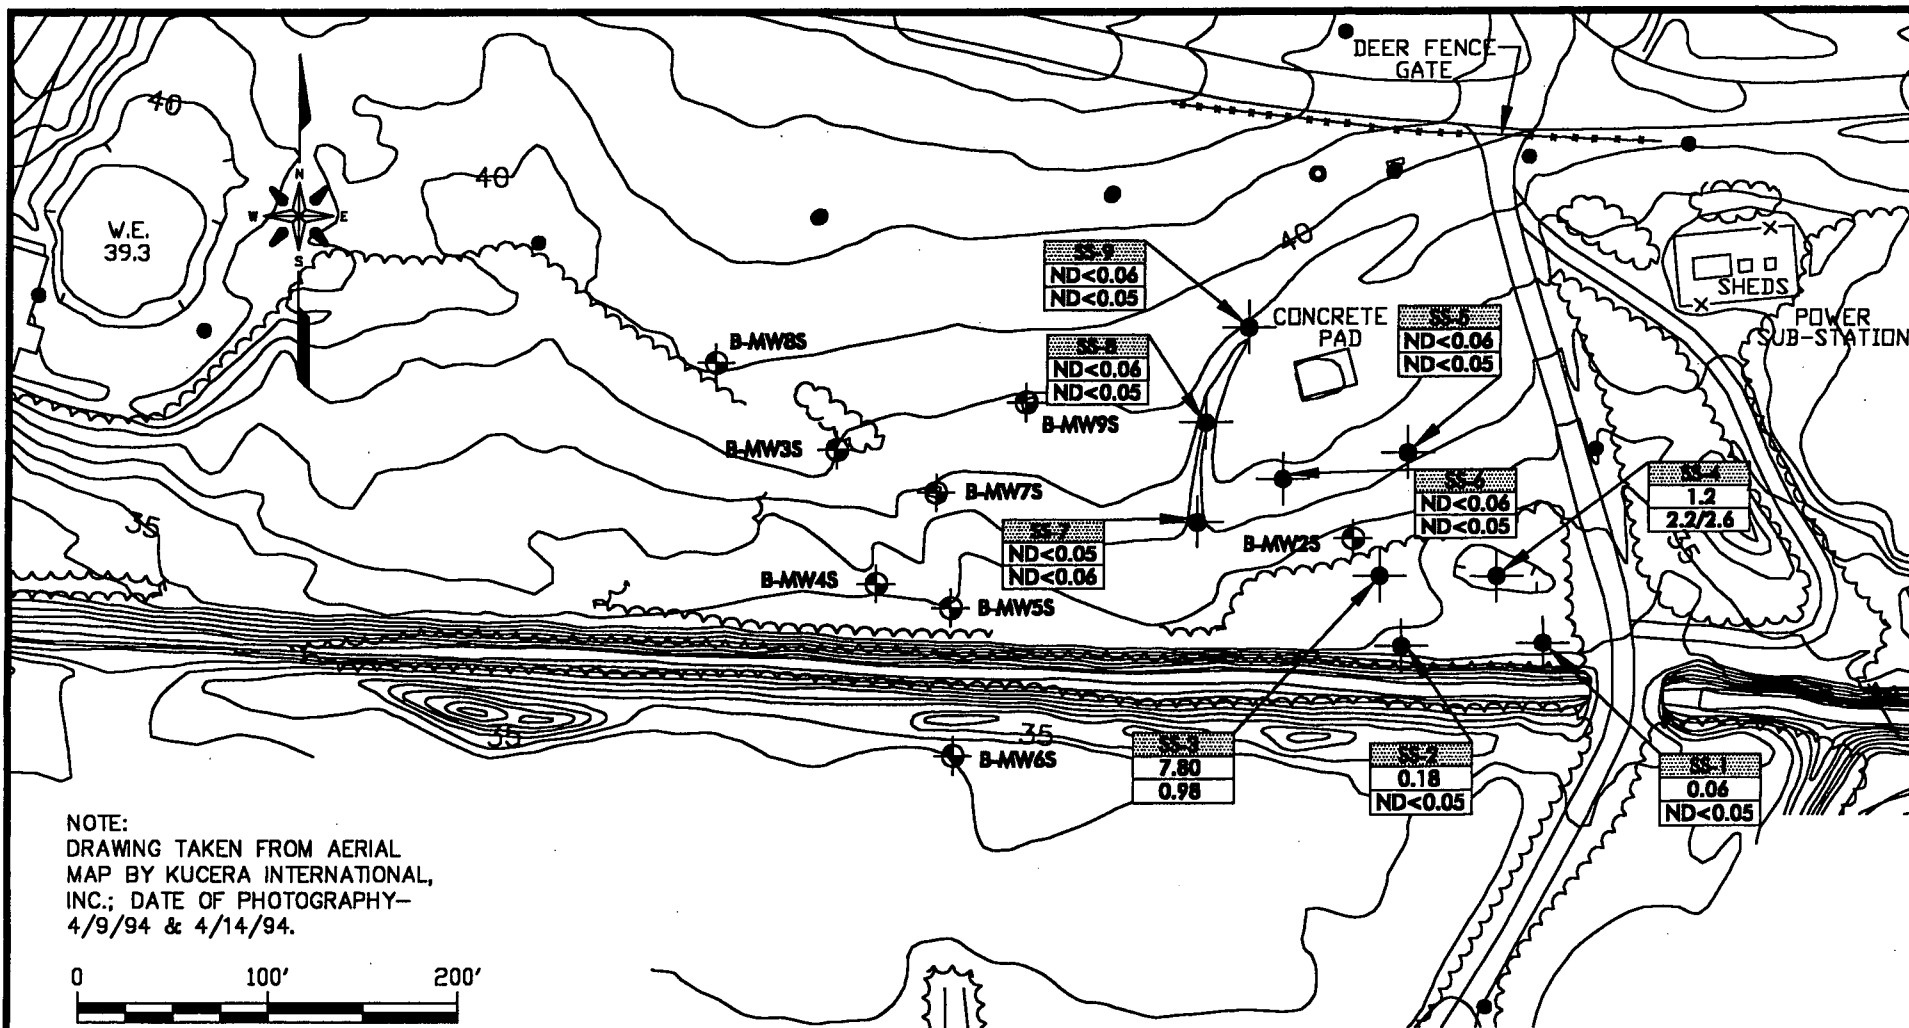
FIGURE 1 MERCURY INVESTIGATION AREA B SURFACE SOIL

Analytical results for four out of the nine sampling locations at Area B indicated the presence of mercury. The upper discrete interval of both samples collected from the old road bed adjacent to the north bank of the South Branch, B-SS1A and B-SS2A, tested positive for mercury at concentrations of 0.06 and 0.18 parts per million (ppm), respectively. Additionally,

both discrete sampling intervals at sampling locations B-SS3 and B-SS4, to the north of the old road bed in the wooded area adjacent to Area B, yielded positive results for mercury. The concentrations of mercury reported for samples B-SS3A and -B were 7.8 ppm and 0.98 ppm, respectively. The concentrations of mercury reported for samples B-SS4A and -B were 1.2 ppm and 2.2 ppm, respectively. A blind duplicate sample of B-SS4B was submitted for analysis and identified as B-10SSA. The concentration of mercury reported by the laboratory for the duplicate was 2.6 ppm, a concentration that falls within 20 percent of that reported for B-SS4B, indicating good analytical reproducibility. Mercury was not detected above the laboratory detection limits (0.05 - 0.06 ppm) in any of the other samples submitted from this area.

Surface soil samples were collected at select locations at Area B (see Figure 1) to determine if any past site activities were responsible for the elevated mercury levels identified in the sediments of the South Branch. Sample locations B-SS1 and -2 were selected due to their close proximity to the most elevated mercury sediments in the South Branch identified during the USFWS studies. Samples B-SS3 and -4 were located in a wooded area approximately 50 feet north of the South Branch. Sample B-SS4 was located in the center of a small topographic depression in the wooded area. Samples B-SS5 and -6 were located downgradient of a concrete pad which past use was of an unknown nature. Samples B-SS7, -8 and -9 were located within a small drainage swale which drains a large portion of the eastern half of Area B.

The results obtained during the TRC investigation clearly supplemented those obtained by the USFWS' previous studies. Two of the sampling locations within the wooded area adjacent to the South Branch in Area B, B-SS3 and B-SS4, indicated positive results for mercury. In particular, the highest concentration (7.8 ppm) was detected in the shallower sample at B-SS3. Positive results were also reported for the shallower soil samples collected at locations B-SS1 and B-SS2, although the concentrations were substantially lower than for the sample at B-SS3. A mercury concentration of 2.2 ppm was reported for the deeper sample at B-SS4. Despite the results for B-SS4, the contamination appears to be more concentrated within the surface soils and diminishes with depth, which corresponds with the South Branch sediment sample findings from the USFWS study. The concentrations of mercury encountered within Area B soils,
